SI B13 08 15
Fuel Systems

January 2016
Technical Service

Service Action: S63 Engine – Check and Replace High-Pressure Injectors

E70 (X5M)

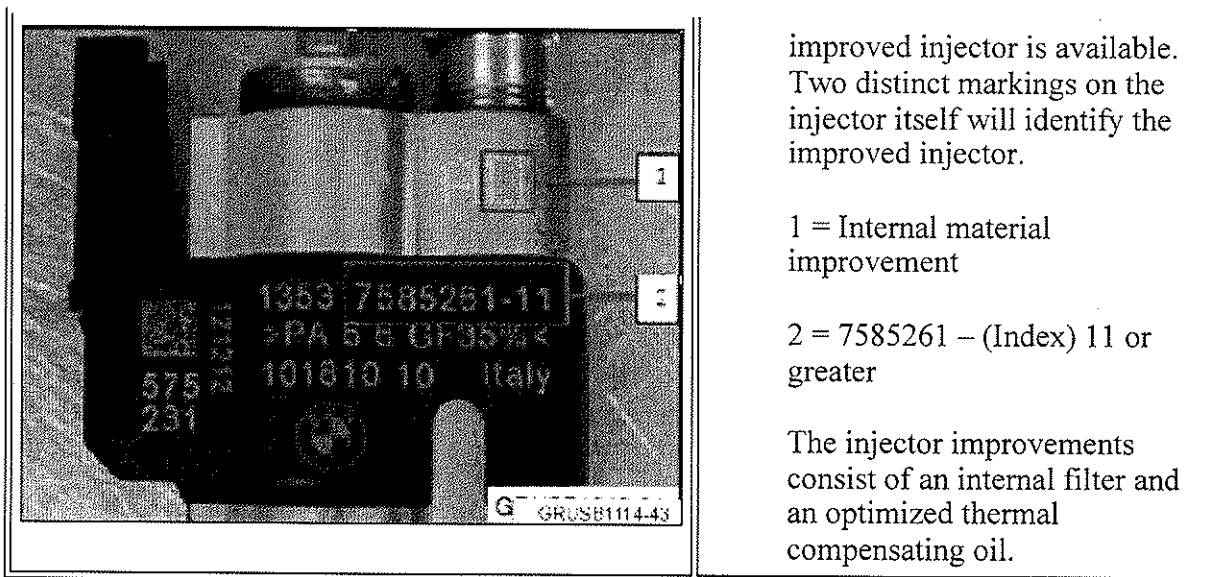
improved injector is available. Two distinct markings on the injector itself will identify the improved injector.

1 = Internal material improvement

2 = 7585261 – (Index) 11 or greater

The injector improvements consist of an internal filter and an optimized thermal compensating oil.

- All injectors that are not index 11 or higher will need to be replaced. Use P/N 13 53 8 648 937 when replacing the injector(s).

If the injector index number is already 11 or greater, take no further action regarding injector repairs.

IMPORTANT: Injectors with index 11 and higher have a different calibration and construction than injectors with index 10 and lower. Due to this difference, injectors with index 11 and higher and injectors with index 10 and lower cannot be mixed on the same engine bank (i.e., cylinders 1-4 or 5-8).
