SUBJECT

Squeaking Noise from the Steering Gear

E46 (3 Series) except M3 models

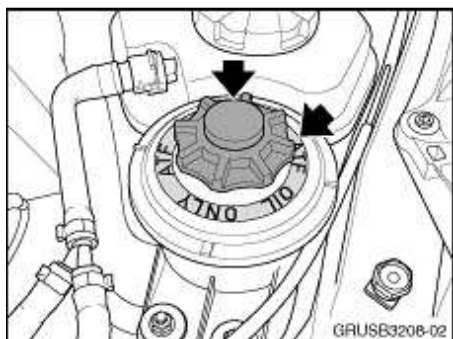
Locate the source of the noise, using a stethoscope or other listening device. If the noise is coming from the pinion shaft area of the steering gear, proceed as follows:

1. Check the fluid level and condition of the power steering fluid. Correct the fluid level as necessary.
2. Determine whether the power steering reservoir is filled with Pentosin or ATF. Power steering systems with Pentosin will be marked on the outside of the reservoir or the cap. Additionally, Pentosin will be green in color as opposed to ATF, which is red. **If the system is filled with Pentosin, contact Teile Clearing for additional assistance.** If the system is filled with ATF,
