This Service Information bulletin supersedes S.I. B63 08 07 **dated June 2007**.

Rear Lamp Repair

E53 (X5)

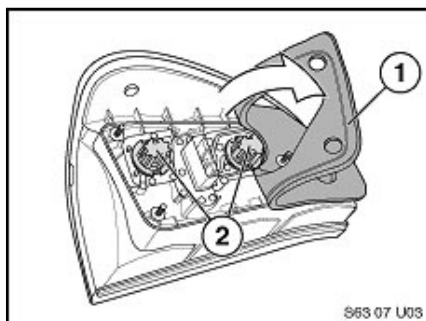
First, confirm that the lamp is suitable for repair - Visually check the lamp for damage, particularly on the lens surface for cracks, chips etc., for water related corrosion damage particularly on the electrical connector, and for excessive erosion at the bulb holder/contact plate (e.g. contact plate burnt through). Lamps with this type of damage cannot be repaired.

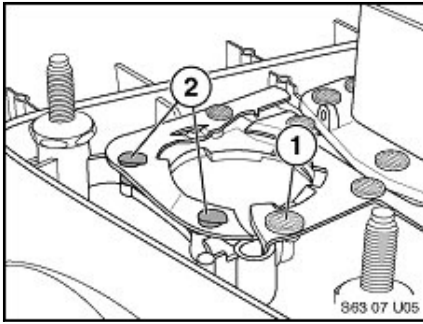
- b. Inspect the circuit board contact surfaces at both locations (1) for evidence of distortion.

c. A distorted circuit board can generally be identified by misshapen circuit board supports. Typically, check where the supports are hot staked:

(1) = OK, (2) = Not OK.

In addition, the circuit board contact surface can be seen to have moved out of position (The surfaces where the bulb holder is attached must all be at the same level)
