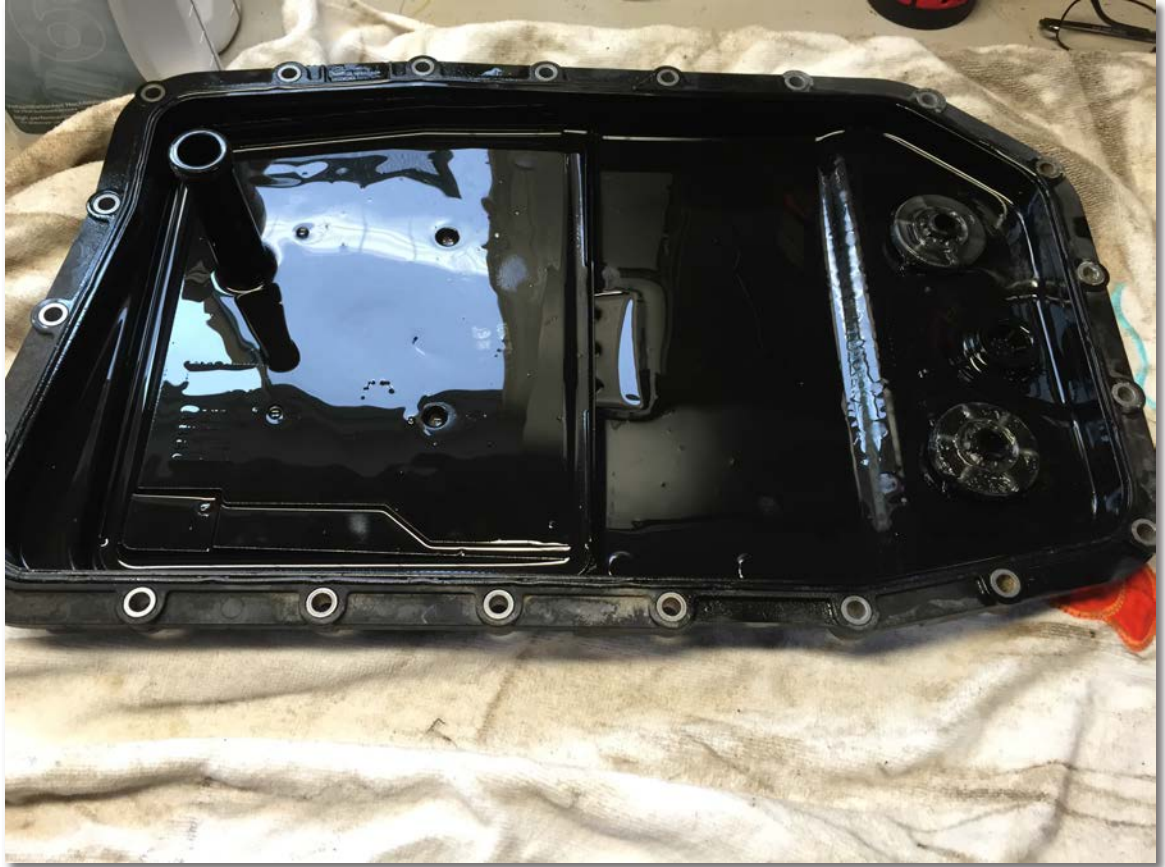
8. With the old pan removed I am happy to see that after 109K the oil is in pretty good condition, no burnt smell, very little material on the magnets not much sludge in the bottom, but the oil is very dark.
