SB-10045284-4261

SI B18 05 12
Exhaust Systems

March 2013
Technical Service

Voluntary Emissions Recall Campaign 11E-A03: Check and/or Replace Emissions Monitoring Components

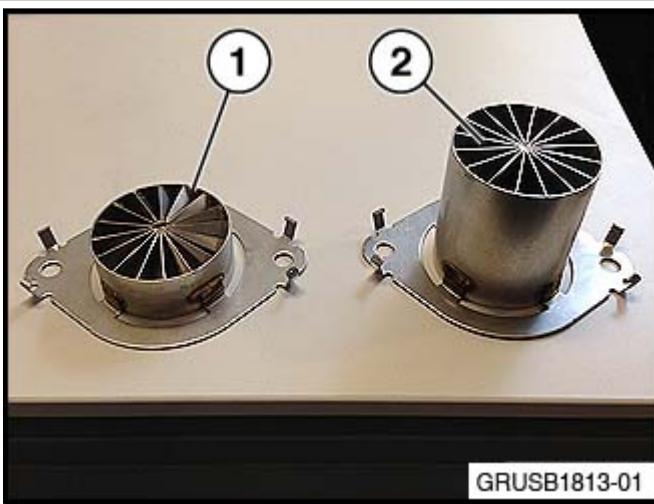
NEW 1. The E90 mixer (1) is shorter than the E70 mixer (2).

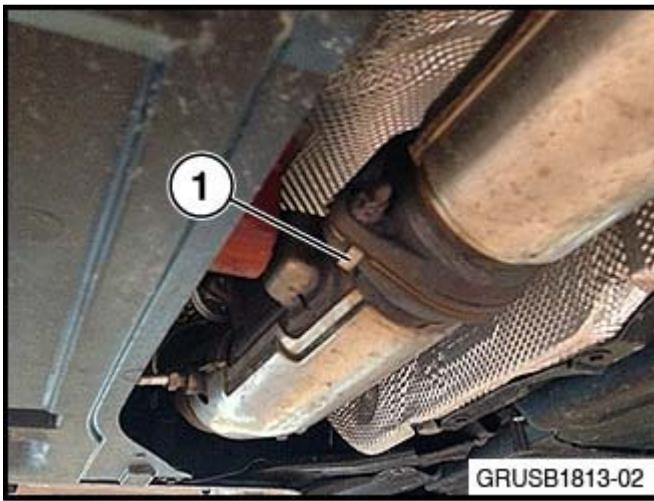
NEW 1. The barrel of the E70 mixer points toward the front of the car. This is easily identified by the mixer tabs wrapped around the front pipe flange (1).

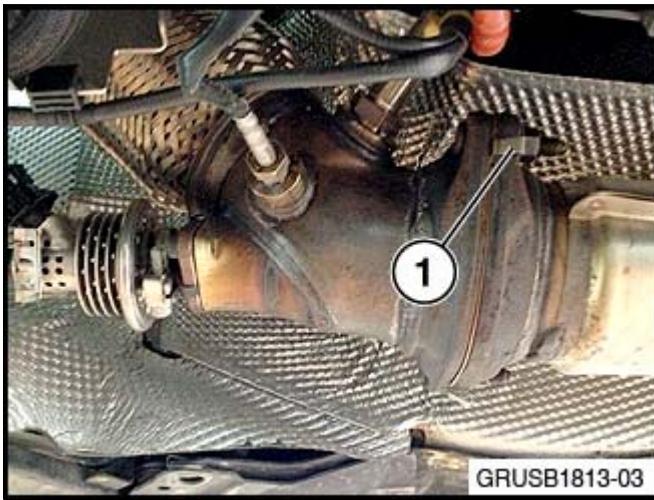
NEW 1. The barrel of the E90 mixer points toward the rear of the car. This is identified by the mixer tabs wrapped around the flange on the SCR cat (1).

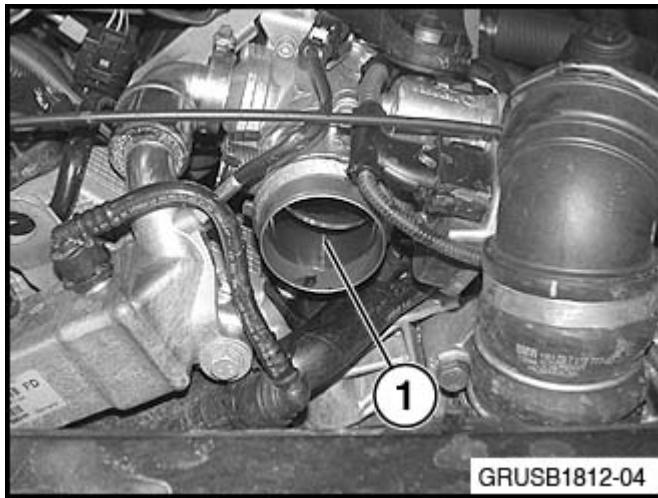
Remove the charge air pipe at the throttle housing (ignition off). Using a flashlight, look through the throttle (1) and inspect the EGR valve.

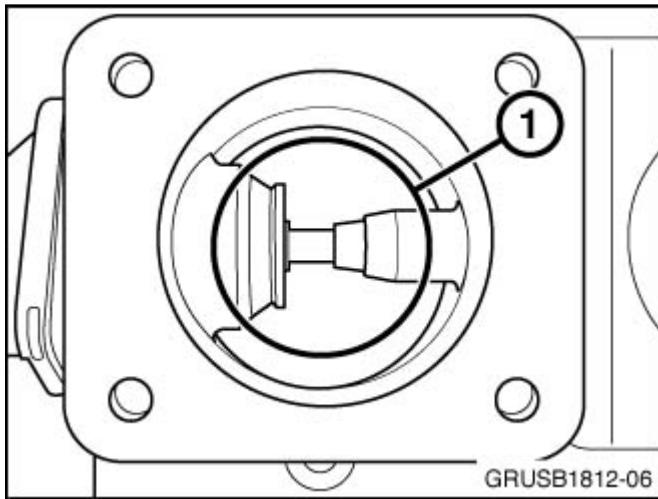
The updated EGR valve (P/N 11 71 8 517 217 or P/N 11 71 8 512 526) has the valve and seat directly in the airstream of the throttle (1). If this valve is installed, no further action is needed. Reinstall the charge air pipe.

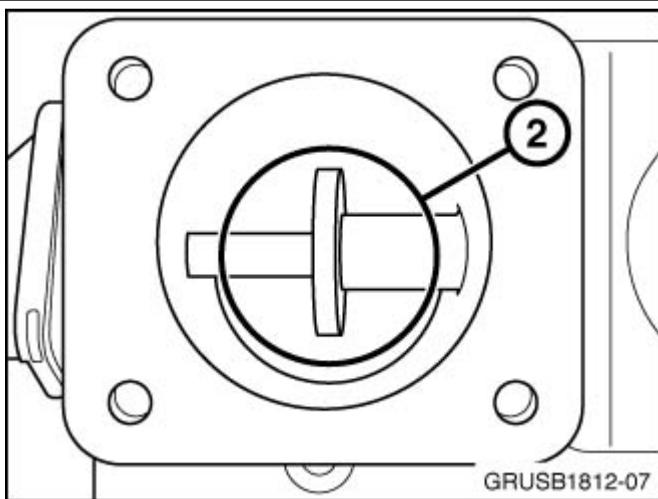
The original EGR valve has a diffuser in the airstream flow from the throttle (2). The valve for EGR actuation is seated further into the EGR airstream. Replace this valve with P/N 11 71 8 512 526 (Repair Instruction 11 71 501).

The DDE will also need to be programmed as part of the Recall. If the EGR valve is replaced, the DDE will need to be programmed after the new EGR valve is installed. This new software package contains the necessary software to adapt to the new EGR valve strategy.
