PROCEDURE

Verify the noise is coming from the rear trunk lid bump stops, and then proceed to step 1.

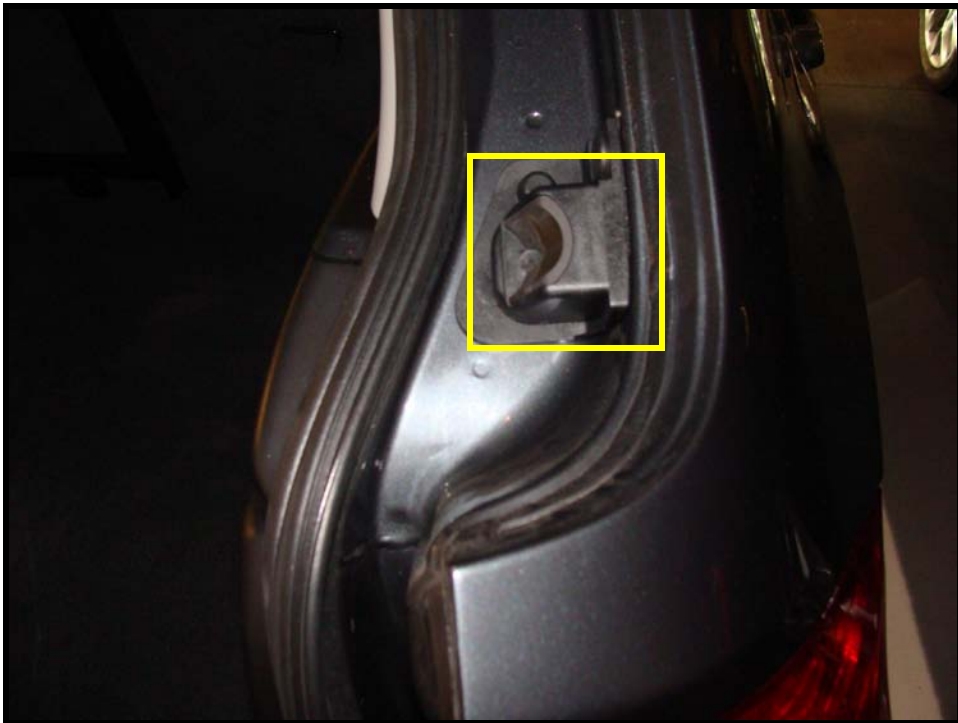
5. This is a close-up of the bump stop adjuster nut. Note: this picture was taken from the underside of the trunk bump stop of the D-pillar area.
