## **BMW X5 Tail Lamp Assembly Repair**

By Myles H. Kitchen  
M.H. KITCHEN & ASSOCIATES  
[www.auto-electronic.com](http://www.auto-electronic.com)  
Email: [MHKitchen@aol.com](mailto:MHKitchen@aol.com)

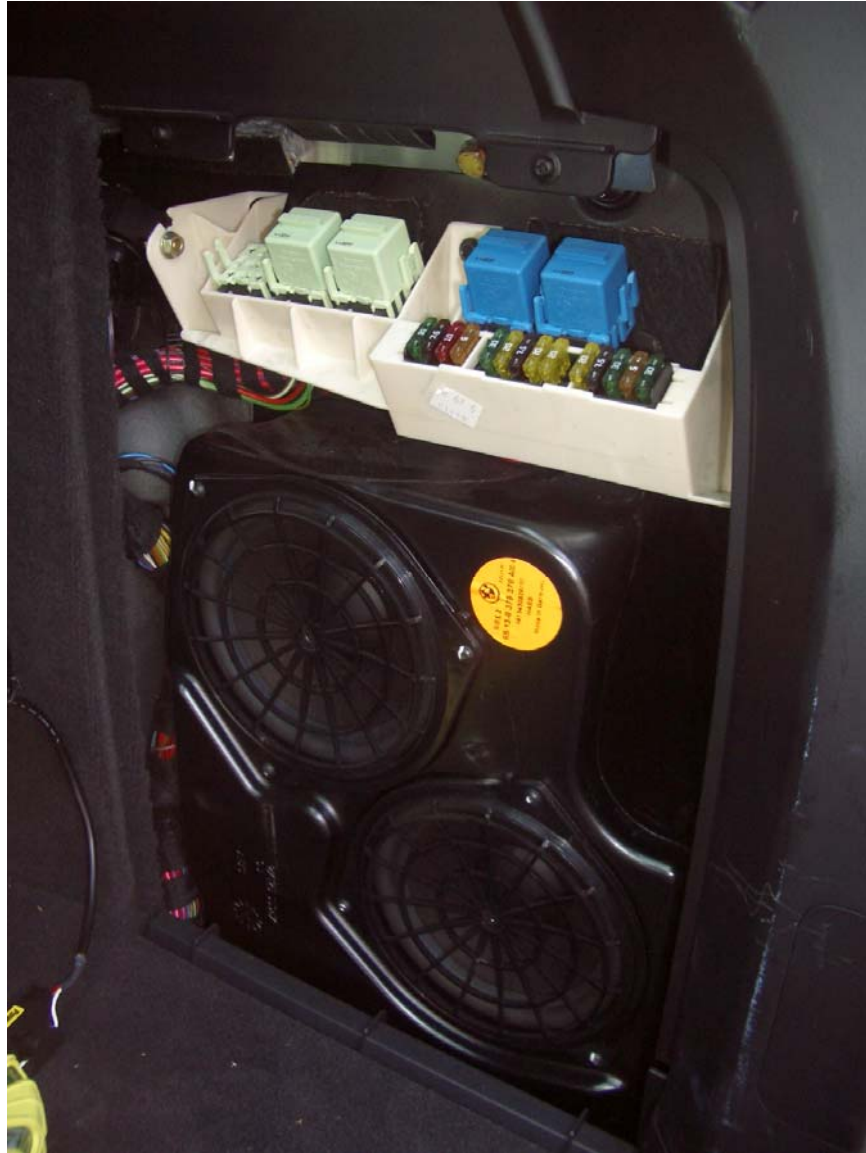
Access to lamp area on right side of vehicle.

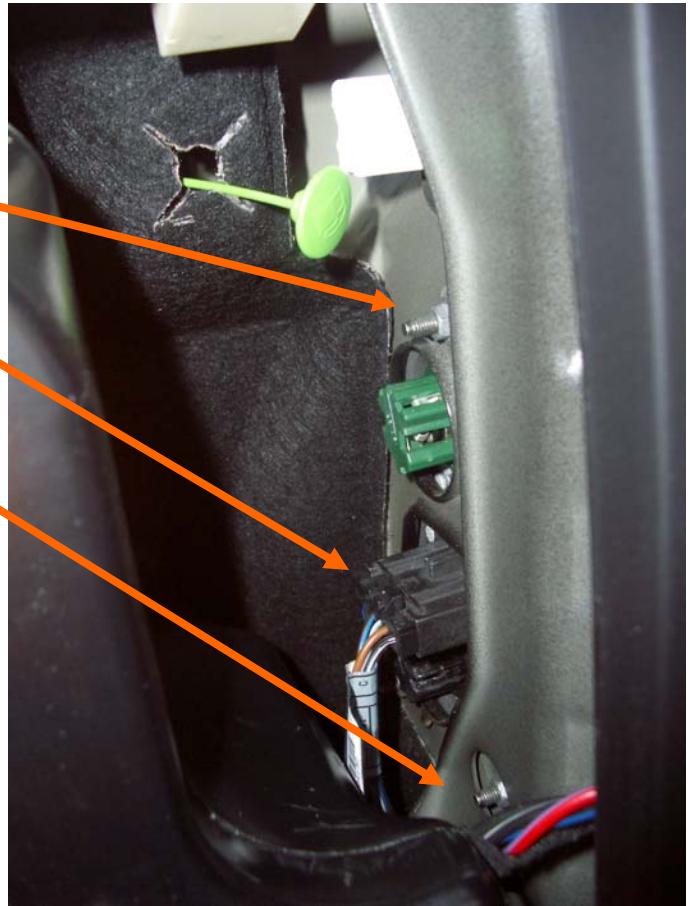
Remove 8mm nut

Remove wiring connector

Remove 2 more nuts (one not shown)

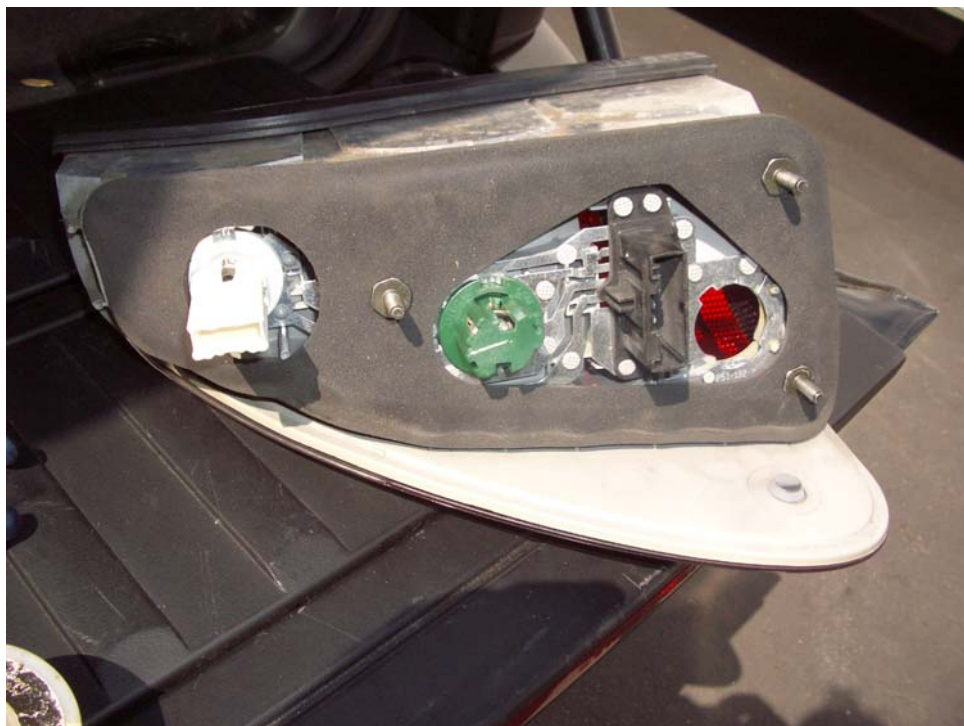
When connector and nuts are removed, then remove lamp assembly from vehicle.

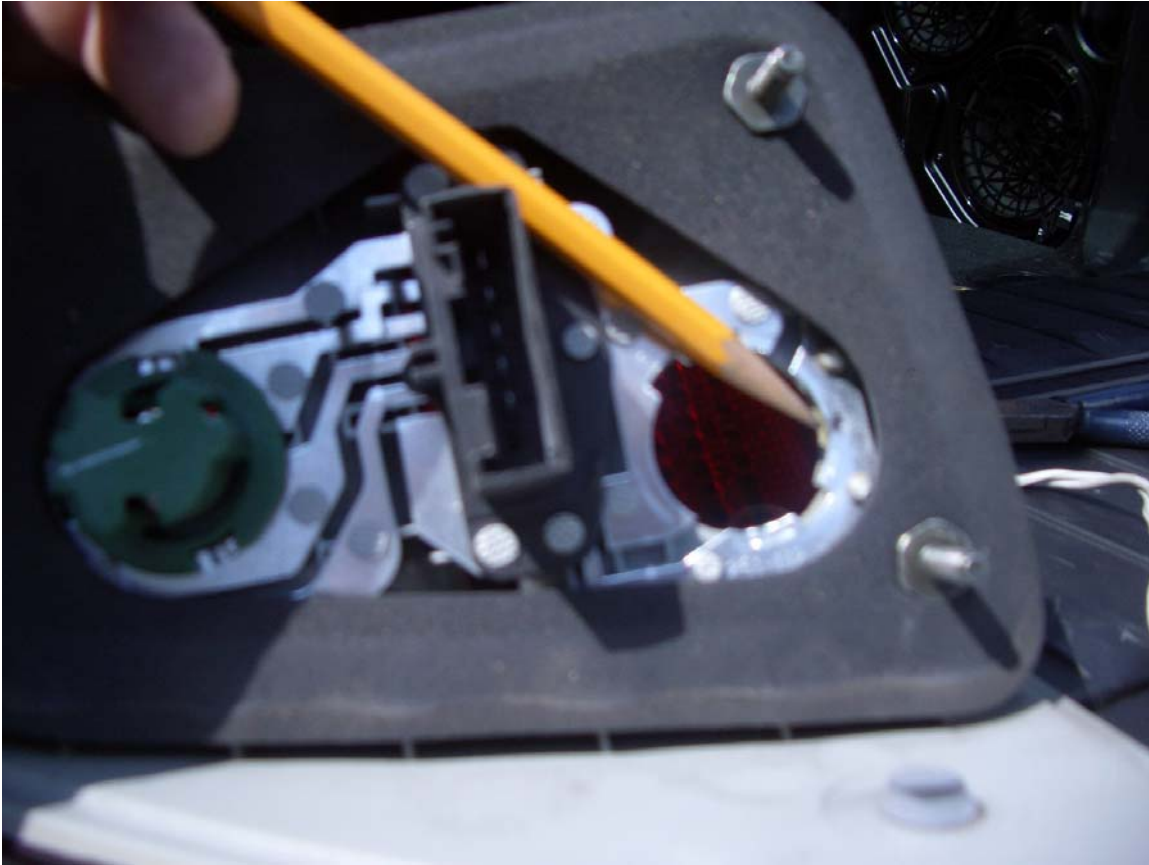
Carefully remove the bulbs from the lamp assembly, noting their orientation so you can reinstall them in the same orientation. At first, it was difficult to find the problem. After conducting a number of continuity tests between all the bulbs, traces, and connector pins, I found that a VERY small area of the plated metal contacts on the lower bulb had been eroded by the electrolysis (metal transfer) from the current carrying light socket. It was evidenced by a small, black dot of oxidized material exactly where the lower bulb socket made contact with the surrounding metal (see photo).

This tiny defect in the conducting portion of the socket was sufficient to cause the poor lamp connection.

The repair is simple. First, clean the area around the defect with some very fine sandpaper and remove as much of the oxidation as possible with an awl or tip of a small screwdriver.

Next, using a soldering iron and some good electrical solder, I laid a layer solder over the affected area, being sure to get adhesion to the remaining good metal around the defect.
