The original reason for changing out the ignition switch was due to a chronic dead battery issue. When it got colder than 30 (F) degrees, the vehicle's battery went dead several mornings when we tried starting. After reading multiple posts on this site, as well as [bimmer.roadfly.com \(http://forums.roadfly.com/forums/bmw/bmw-x5-e53/8554332-1.html\)](http://forums.roadfly.com/forums/bmw/bmw-x5-e53/8554332-1.html) I came to the conclusion that the chronic dead battery issue with my 2002 X5 was probably due to a bad ignition switch. Some other issues I had were specific to the dashboard in that none of the gauges were working (except speedometer) and the temperature gauge - which worked, but was in Celsius (default German setting).

Replacement Directions:

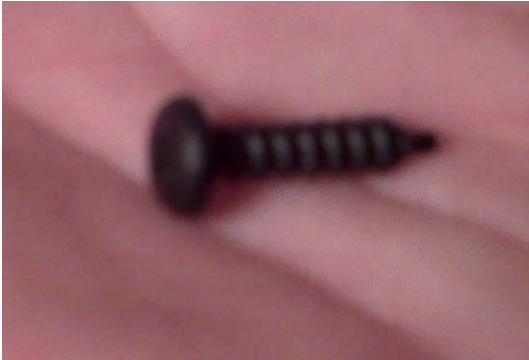
Picture 1:

Step 3: There is a plastic Philips screw (Picture 1) on top of the plastic cover at the 12 o'clock position, and one T-25 screw on the bottom (6 o'clock position) plastic cover (Picture 2 & 3). Once those are out, carefully remove the top and bottom plastic trim around the steering wheel column (a credit card came in handy when separating the top from the bottom cover) (Picture 4 & 5). Pull out the lower cover as far out (and down) as possible. Be very careful, as to not break tabs. After removal of bottom plastic piece, I recommend putting a piece of tape on the clip (Picture 6) (which is what the bottom plastic piece screws into on the bottom of the steering column) to keep it from falling down and behind the dash board (speaking from experience). Picture 7 shows the clip installed on the bottom of the steering column (again, the 6 o'clock position) which accepts the screw from Picture 3.

Step 8: No secrets putting it back together, just reverse the instructions. A word of advice - be careful when re-installing the top screw (12 o'clock position) (from the first sentence in step 3) for it is plastic, as such, don't over tighten.

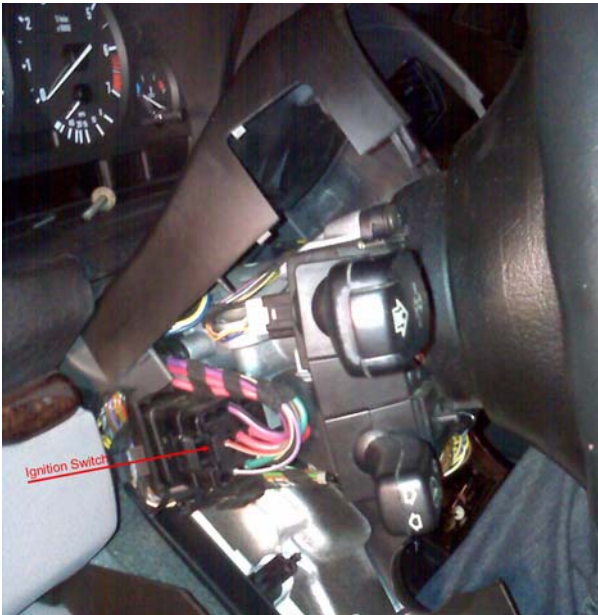
Picture 8:

Step 4: You can see the ignition switch from the drivers door looking in (Picture 8), pull the tab on the wiring harness (Picture 9) and remove the connector from the ignition switch.

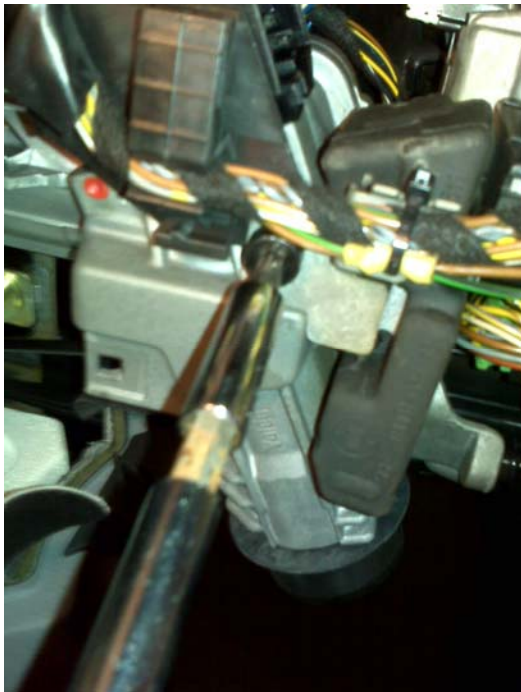
Picture 10:

Step 5: There is a black bracket around the ignition switch held in by two torx 30 screws. I removed the bottom one completely (Picture 10) and loosened the top one (Picture 11 & 12) with

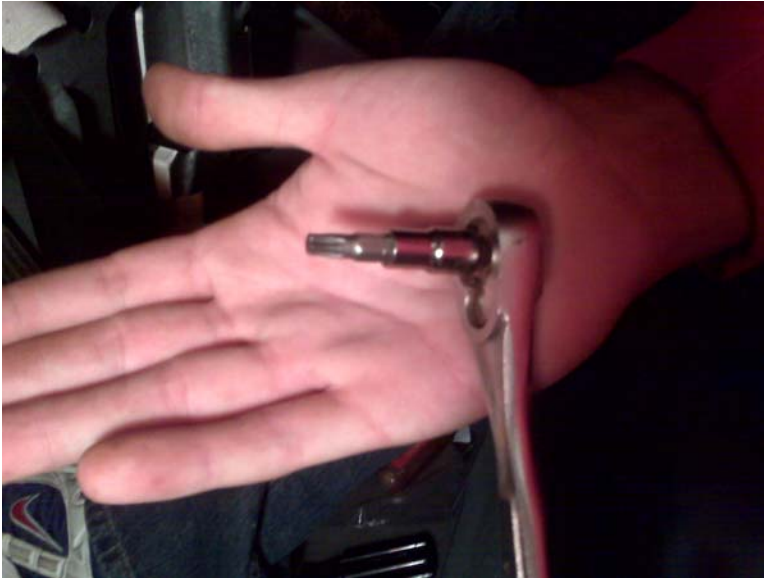
Picture 13:

the ratchet drive showed in Picture 13.

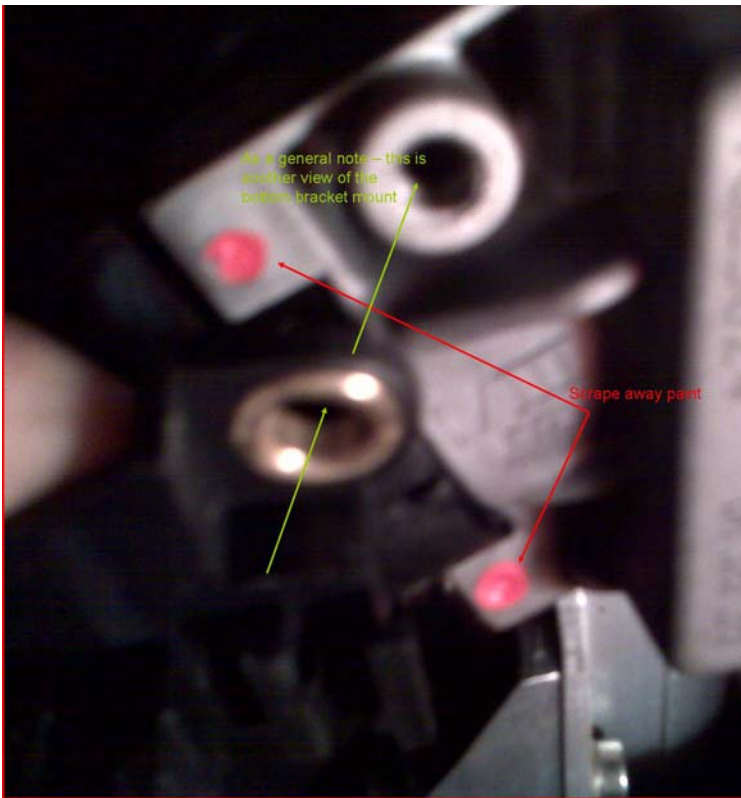
Picture 14:

Step 6: The switch itself has two very small screw pins on the bottom of the switch that hold it in place. The heads of the very tiny screw heads are marked with red paint (Picture 14). Scrape the paint away (I used a razor blade) and back the screw pins out using the 1/4" drive with 1/8" slotted tip (or a small screwdriver as noted in Picture 15 (I also used a pair of pliers to turn the small screw driver), you don't need to remove them completely.

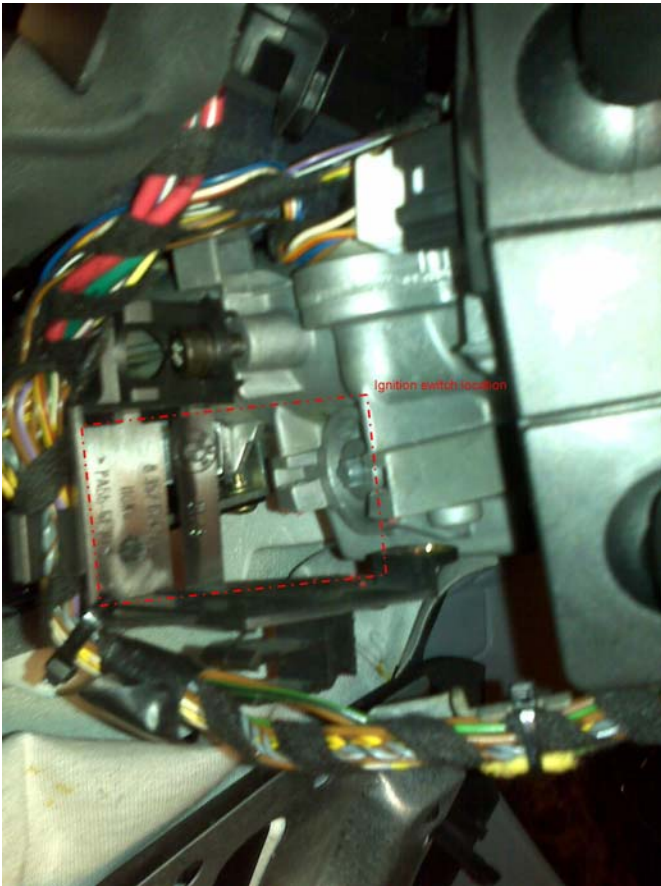
Picture 16:

Step 7: Pull the ignition switch out (Picture 16 shows ignition switch out), note the position of the input shaft on old ignition switch, align the new switch to the same position and install. Picture 17 shows what the ignition switch was attached to. The red paint remaining to the left and right shows where the small mounting screws were backed out.

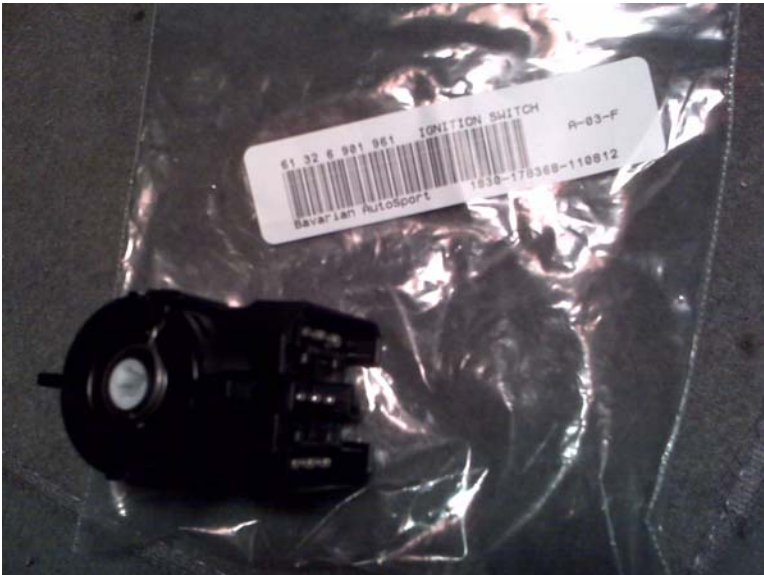
Picture 18:

Ignition Switch - Part #61 32 6 901 961 (purchased from BavAuto.com for \$49.95) (Picture 18)
