SB-10045284-4261

SI B18 05 12
Exhaust Systems

March 2013
Technical Service

Voluntary Emissions Recall Campaign 11E-A03: Check and/or Replace Emissions Monitoring Components

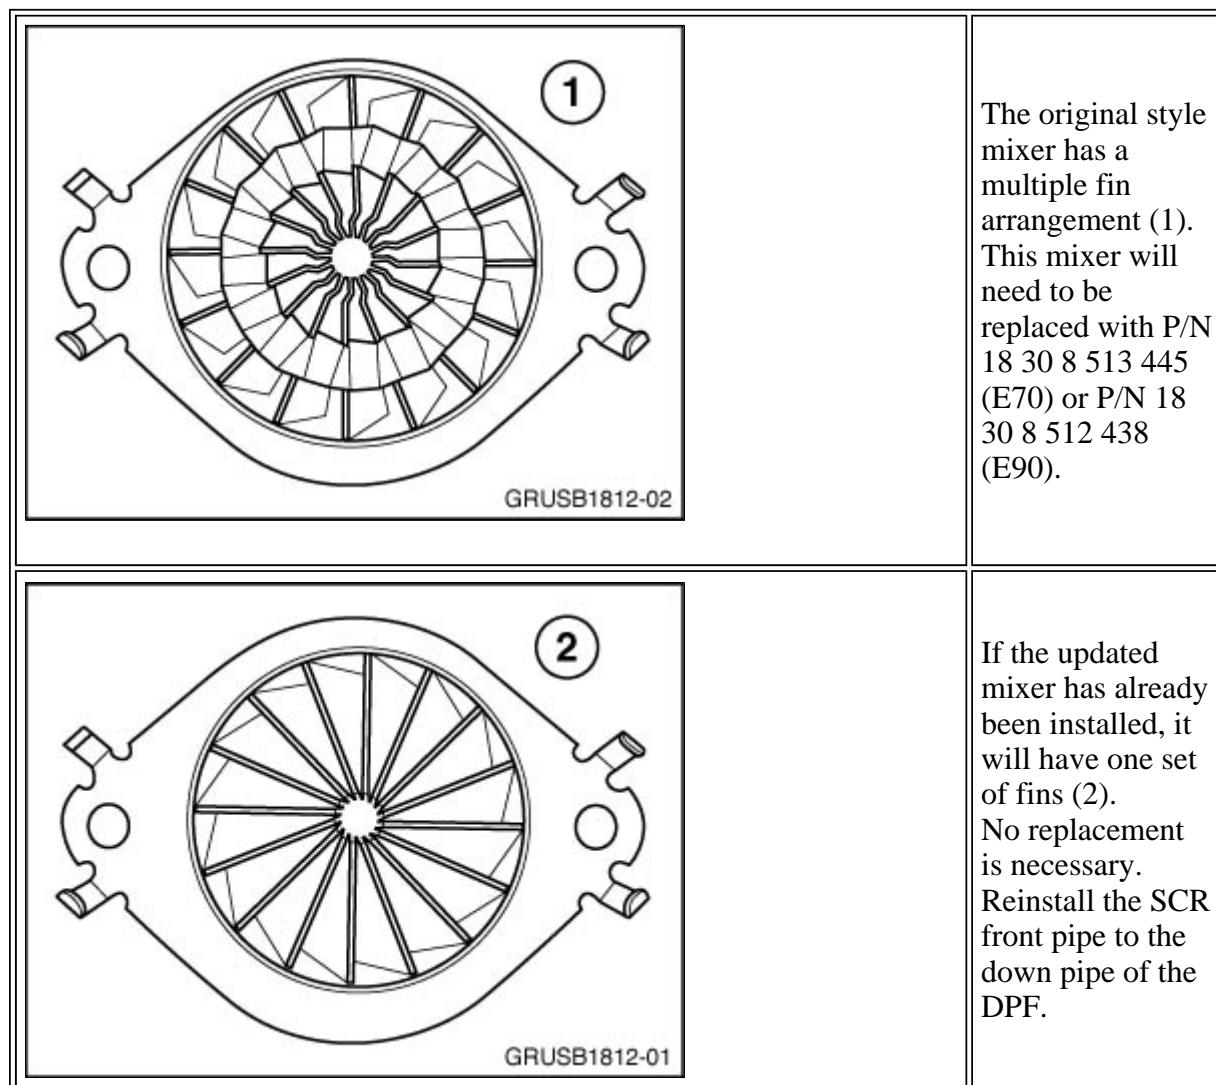
Inspecting the mixer:

Remove the Selective Catalyst Reduction (SCR) catalyst from the exhaust after the particulate filter to gain access to the mixer.
